Failure Analysis and Mechanical Tests of Failed Aluminum Alloy 7277 Rivets on Armored Vehicle Launched Bridges

ARL-TR-1195

September 1996

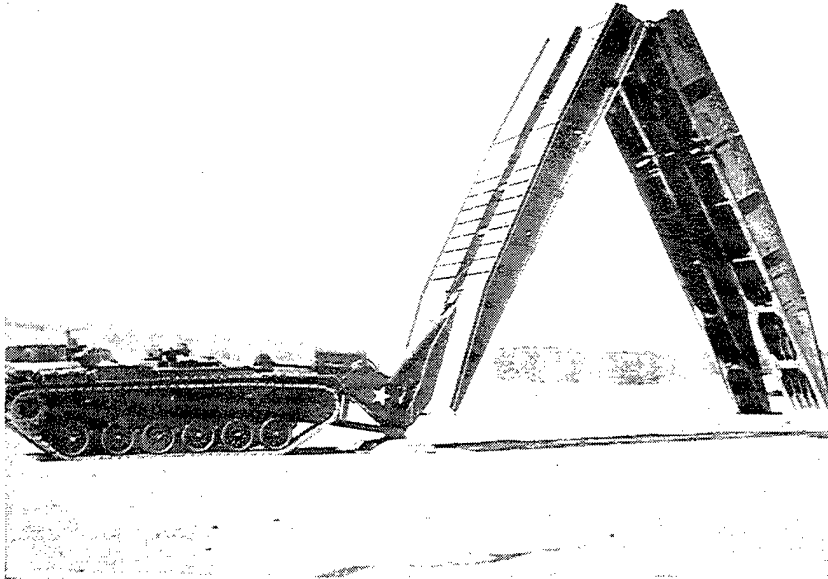
Figure 1. AVLB (at right) in the scissoring formation from the bridge launcher (at left).

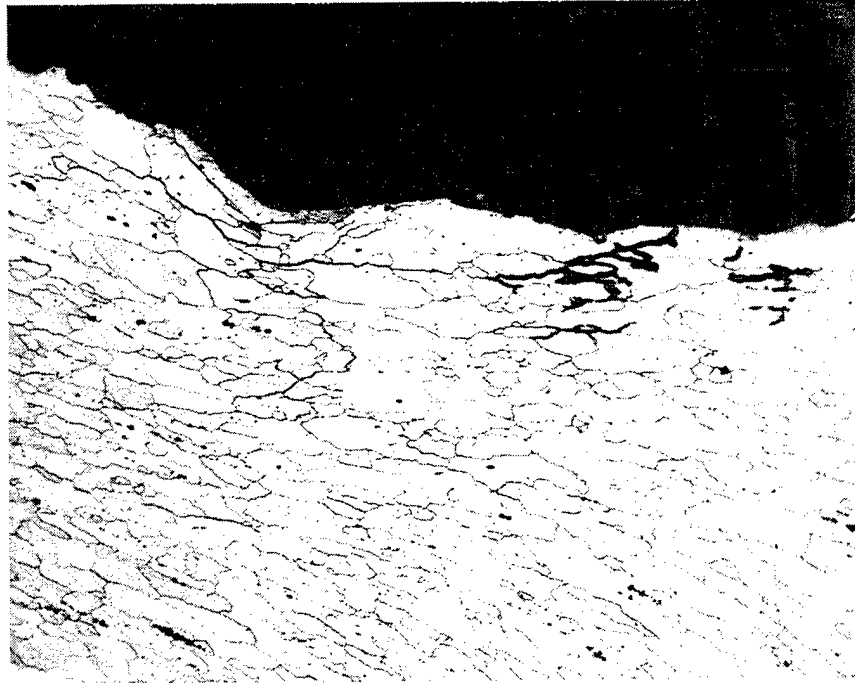
Figure 9. As-polished microstructure of the aluminum rivet in Figure 8. Intergranular corrosion and cracks are present in the small corroded area in head-to-shank fillet, indicative of stress corrosion cracking. Magnification: 170x.

Figure 10. Etched microstructure of the same area in Figure 9. Magnification: 170x. Keller's etchant.

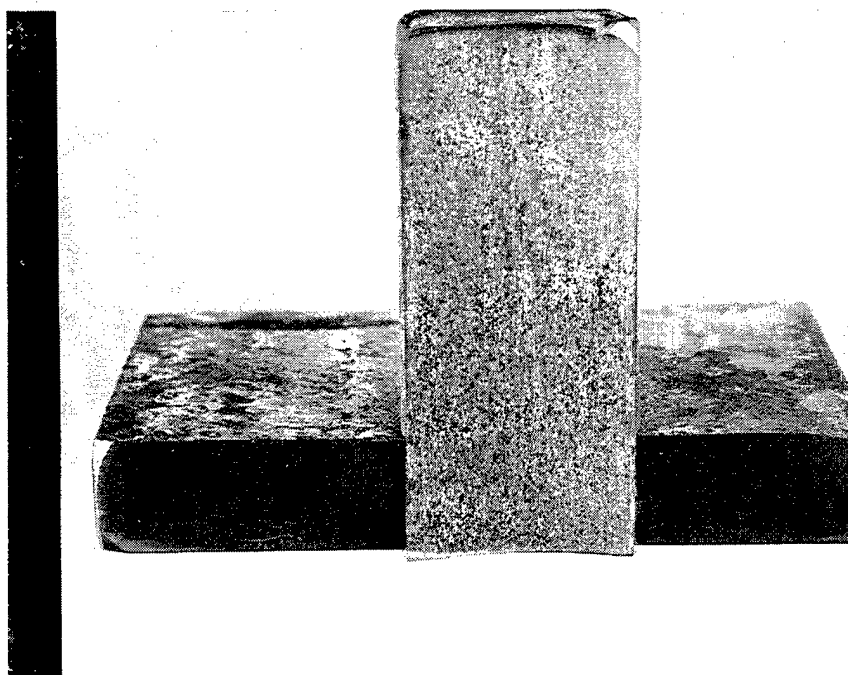
Another sample examined was the corroded aluminum rivet with its one end still in a rivet hole of an aluminum spacer bar (see Figures 14 and 15). Both rivet shank and spacer bar were heavily covered with white corrosion products. Figure 16 shows the microstructure containing small corrosion pittings in the surface of the corroded rivet shank in the rivet hole. Small cracks had initiated from the bottom of the pits.

Figure 15. Etched cross section of the sample in Figure 14 to show end of the rivet shank still in the rivet hole of the spacer bar. Magnification: approximately 1.6 \times . Keller's etchant.

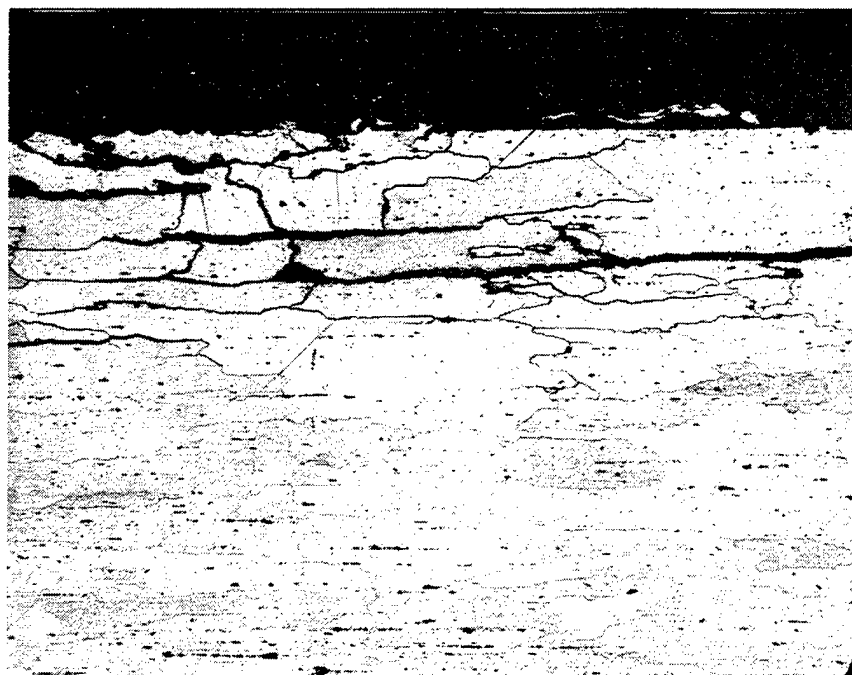
A 4-in-long corroded aluminum rivet sample with heavy white corrosion deposits on the surface of its shank also was examined (see Figure 17). Figures 18 and 19 are the microstructure of a corroded area on the shank surface. Intergranular corrosion and cracks were present on the corroded surface.

Figure 18. As-polished microstructure of a small corroded area on the surface of the rivet shank in Figure 17 covered with thick corrosion products. Intergranular corrosion and cracks (SCC) were observed at the corroded surface. Magnification: 100 \times .

Figure 19. Etched microstructure of the same area in Figure 8. Magnification: 100 \times . Keller's etchant.

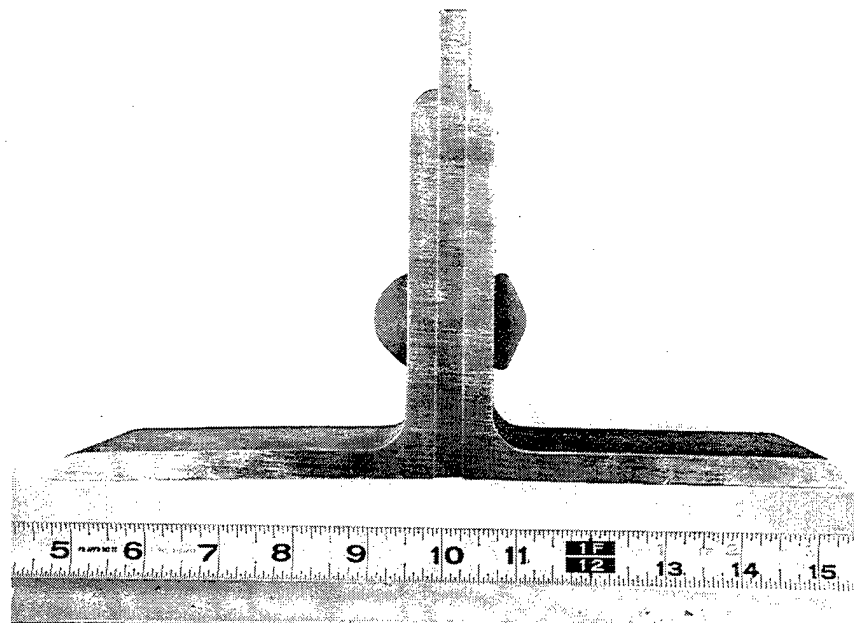
Figure 20. A shear aluminum test specimen cut from AVL B panel assembly, showing the rivet at the low position. The specimen was composed of two angles with the middle girder plate to serve as a plunger to shear the rivet.

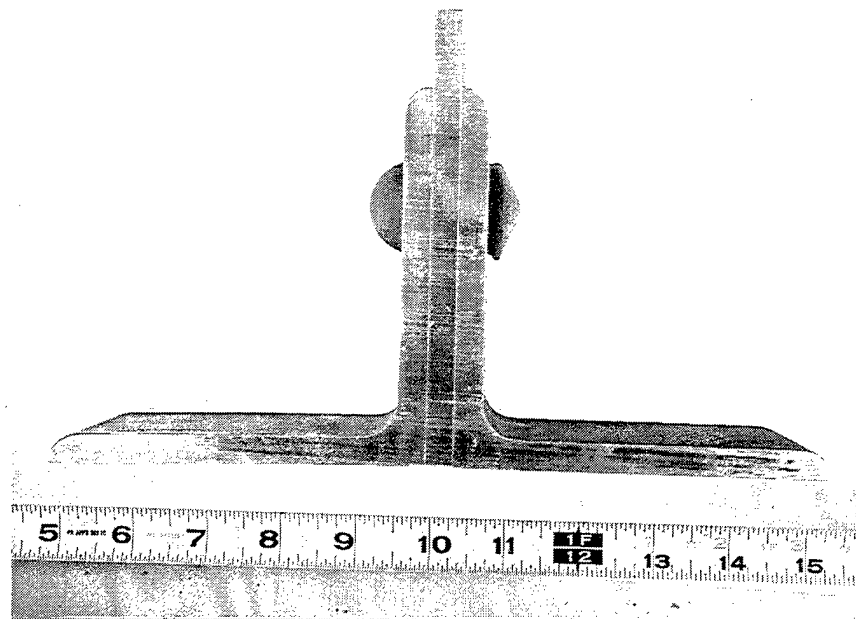
Figure 21. A shear aluminum test specimen showing the rivet at the high position.

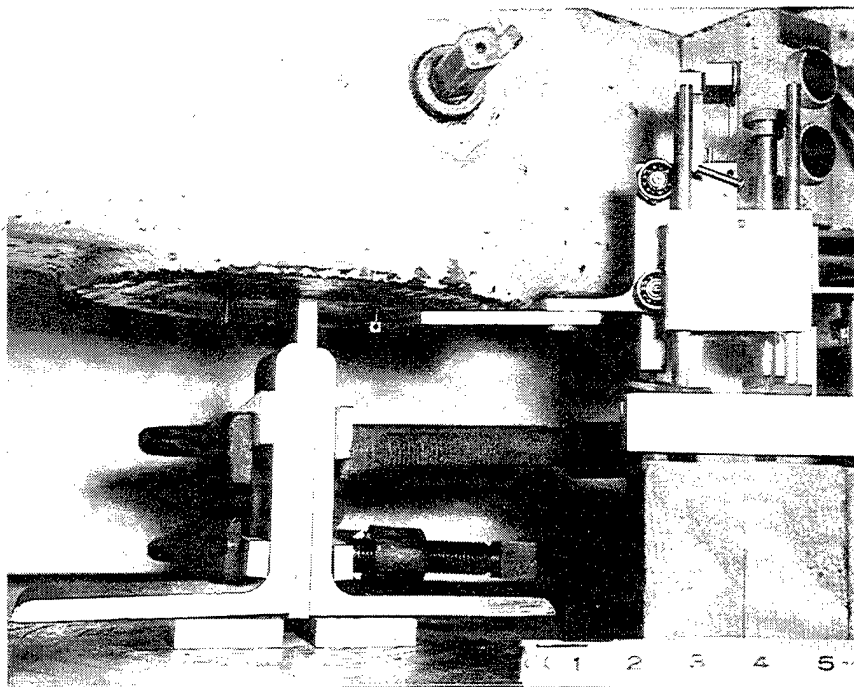
Figure 22. A typical setup of the AVLB rivet shear test specimen on the testing machine for double shearing of the rivet shank. The clamps were used above and below the rivet to prevent both angle vertical legs from spreading apart during the test. The test specimen sat on top of two 0.5-in-thick aluminum blocks to allow the bottom of the girder plate plunger to extend beyond the bottom of the angle horizontal legs during the test. The load was applied in compression to the protruded top of the specimen plunger under the compression head in the cross head of the testing machine. A deflectometer was used to measure the movement of plunger to obtain load-deflection curve.

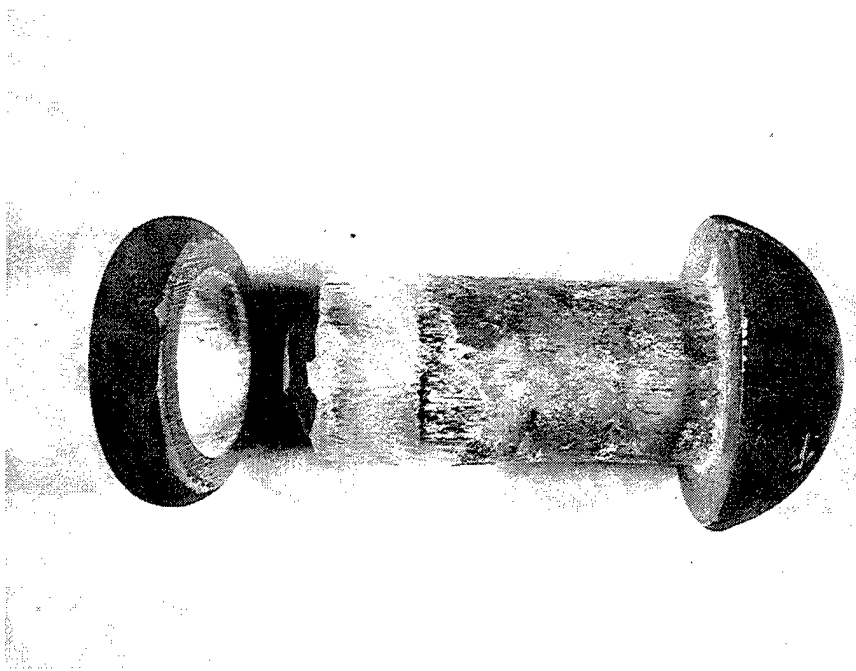
Figure 30. A view of the rivet (specimen D) with the sheared driven end (left) after the pull test.

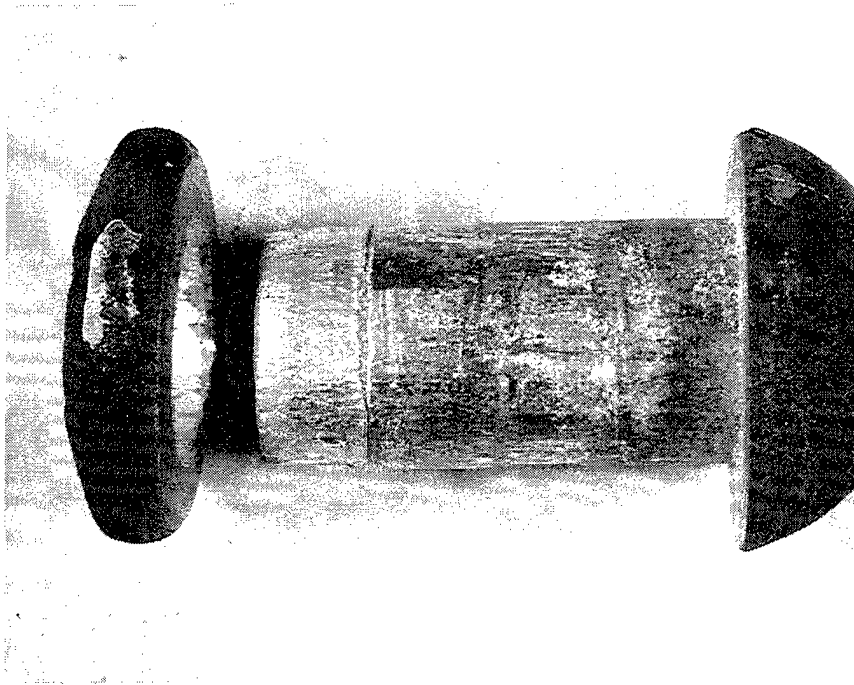
Figure 35. Enlarged view of specimen A "Good" rivet which sheared at its driven end through the rivet hole of the angle leg during the pull test. Magnification: approximately 2x.

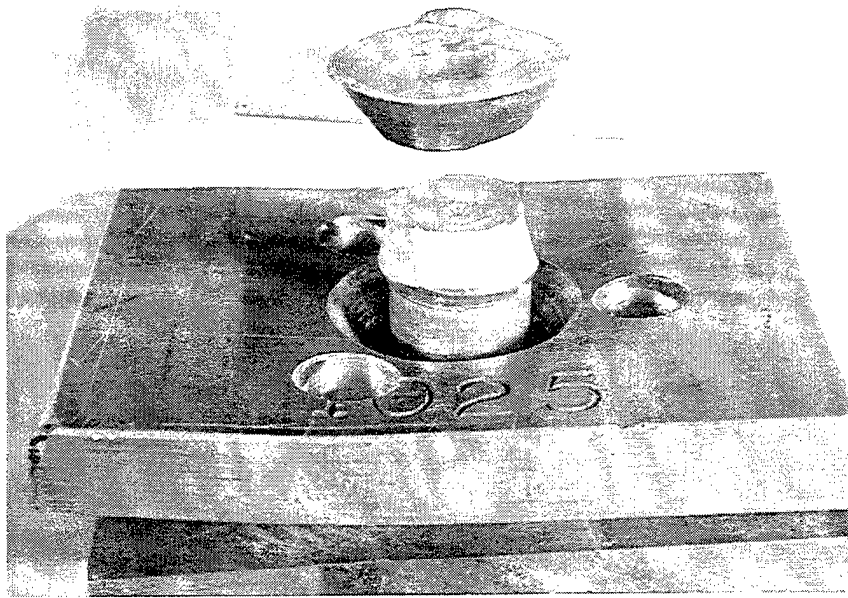
Figure 39. An example of the shearing at the flat countersunk head of unpainted 1,025° F rivet sample.

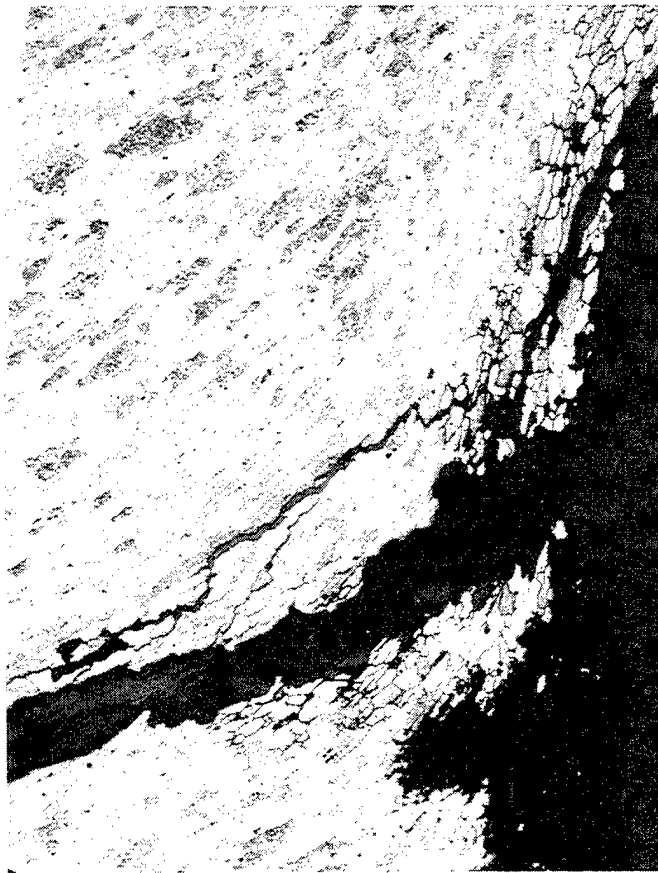
Figure 44. As-polished microstructure of stress corrosion cracks on the shank of corroded rivet sample 10 near the fillet. Note the intergranular corrosion on the surface of the shank (right side) and in the major cracks. Magnification: 100×.

Figure 45. Etched microstructure of the same area in Figure 44, showing the grain flow formed by the head-forming operation. Magnification: 100x. Keller's etchant.

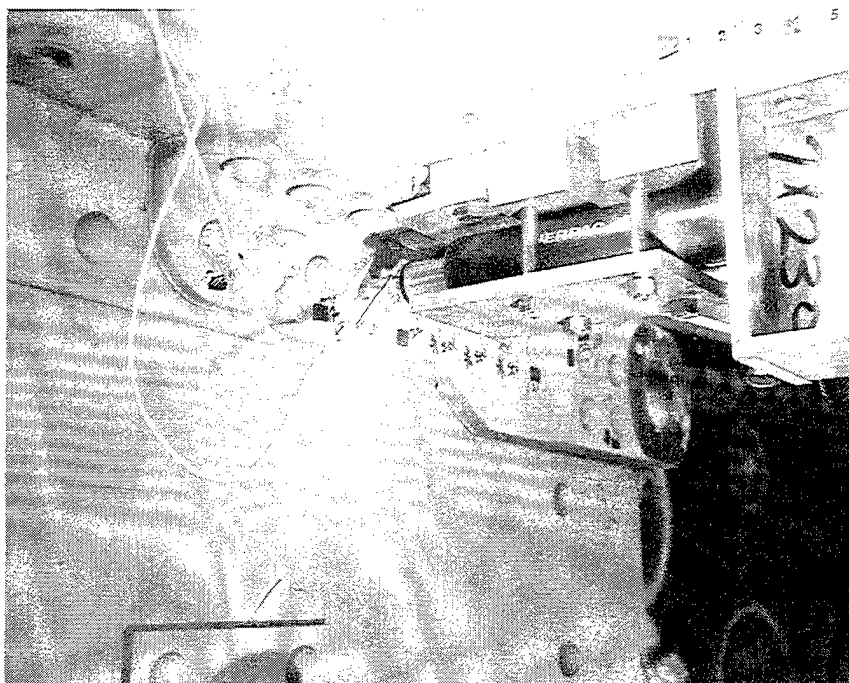
Figure 50. Closeup view of the special jig in Figure 49, showing the placement of the 0.5-in-diameter steel pin (with two strain gauges) between the headless end of the rivet and the plunger end of the hydraulic cylinder. This jig was setup for the testing of the no. 4 rivet. The cables from the strain gauges were connected to the strain indicator not seen in this photograph.

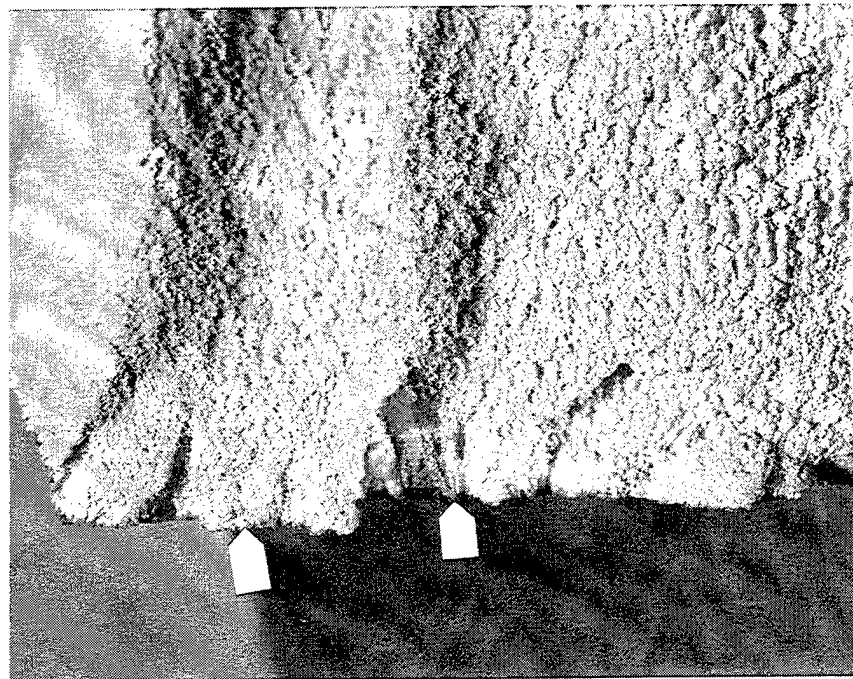
Figure 56. Closeup view of small fatigue crack (top edge) at B in Figure 52 after the eye piece broke from the forged female center hinge at 115-ton load.

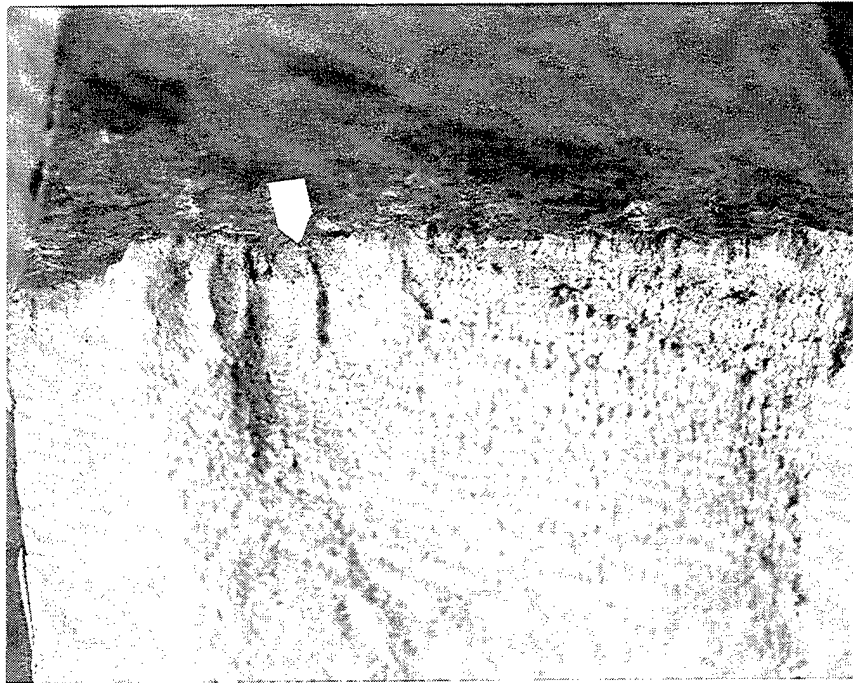
Figure 59. Closeup view of the fracture at A in Figure 54 showing small fatigue cracks (top edge) in the eyehole where the brittle fracture initiated in the connector.

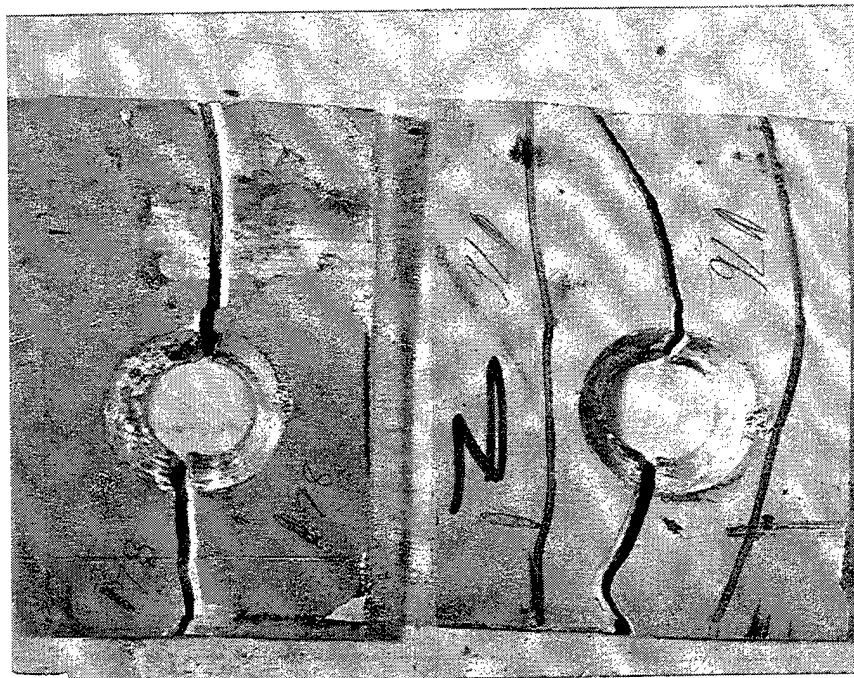
Figure 60. Prior cracks at first countersunk hole of the inner outboard bottom chord angles of the male center panel assemblies that had occurred during the fatigue test of 3,000 simulated MLC-70 tons crossings. See Figure 62 on the extent of corrosion on the surfaces of the other side.

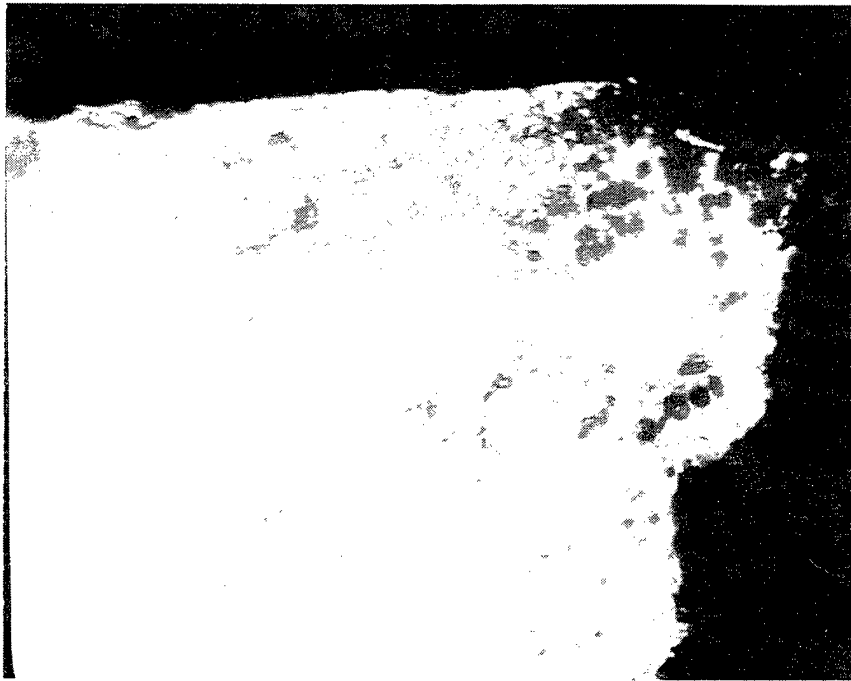
Small metallographic specimens for microstructural examination were cut from the fractured surfaces of the selected major bridge components in the areas where the cracks initiated. Figure 63 reveals the extensive network of intergranular corrosion at the initiation site of the fatigue crack at point A in Figure 52, the broken inboard female center hinge eye. Figures 64 and 65 show some intergranular corrosion on the corroded surfaces of both bottom chord angle samples in Figure 60 near the crack initiation sites of the fractures in the rivet holes.

Figure 63. Microstructure of the fracture at A of the broken inboard female center hinge eye in Figure 1.

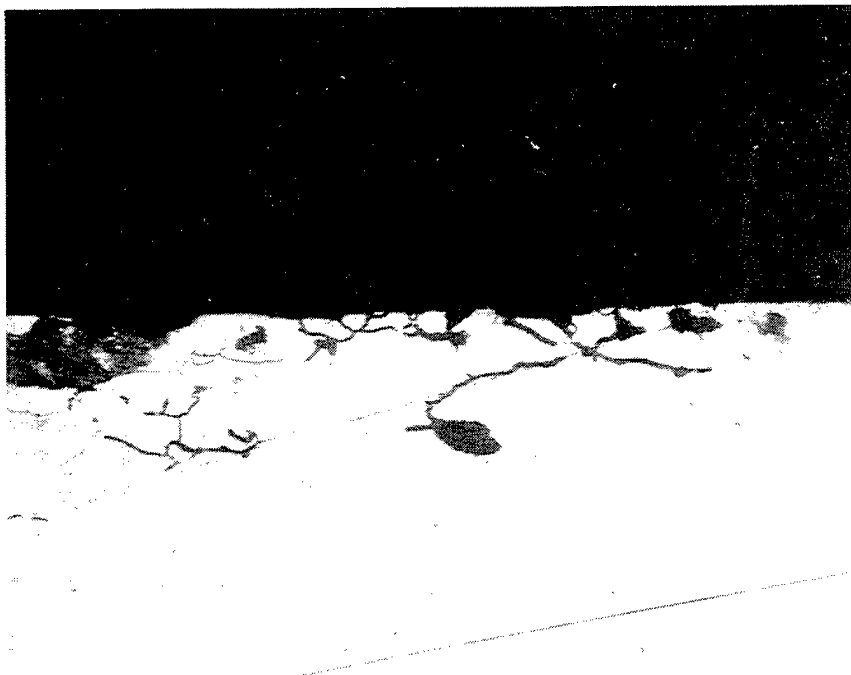
Figure 64. Microstructure of the corroded surface (top edge) near the fracture of the cracked bottom chord angle from male center panel assembly S/N 176 in Figure 62. Note the intergranular corrosion on the surface. Magnification: 160 \times . As-polished.

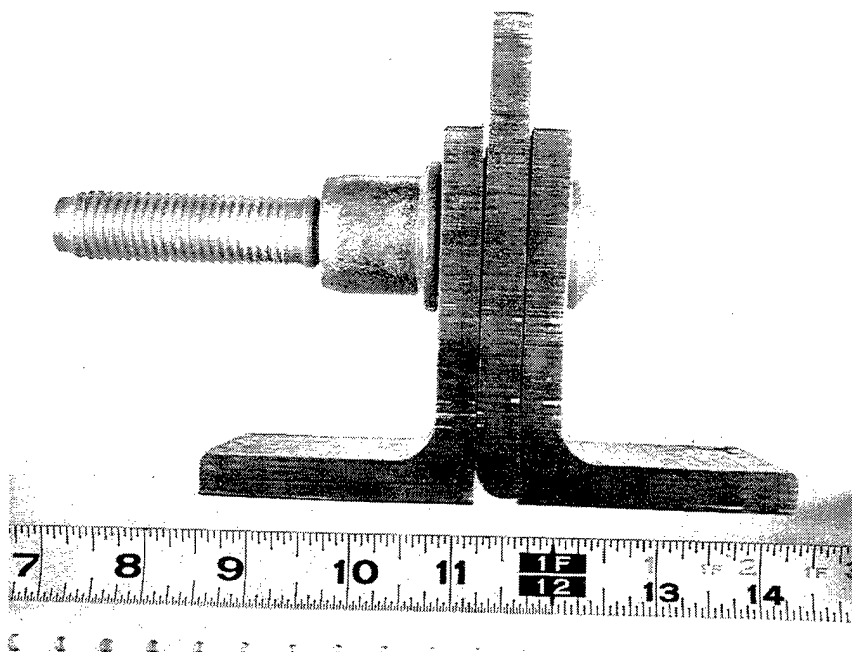
Figure 67. A view of the Huckbolt fastener in the rivet holes of the aluminum parts prior to swaging of the collar. The grip installation stem will be grabbed by the installation tool and broken off after the collar is swaged by the anvil of the tool.

When the supply of new rivets is gone, ANAD will use another type of fasteners that does away with hot driving as was done on aluminum alloy 7277 rivets. The new fastener is called a Huckbolt fastener (see Figure 66), consisting of an aluminum pin with the locking grooves and installation stem and an aluminum collar. "Huckbolt" is a registered trademark of the Huck International, Inc. With the use of the installation tool, the collar is swaged onto the locking grooves of the pin, and the stem is broken off like a familiar "pop" rivet (see Figures 67 and 68).

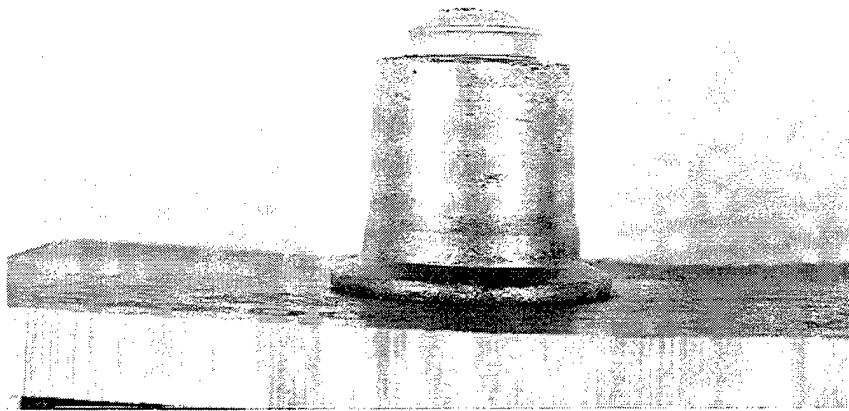
Figure 68. Closeup view of the fully swaged collar of the Huckbolt fastener after the installation. The grip stem of the pin was already broken off.
